# ARBORICULTURAL REPORT EKORN TREPLEIE AS APPROVED ARBORICULTURAL CONTRACTOR FIRM ESTABLISHED 2013

Name/ reference: arbreport025kongensgate Customer details: Oslo House As /Bjørnar Johnsen +47 917 75 878 <u>Bjornar.johnsen@oslohouse.no</u> Address/ Grdsnr: Kongensgate 21, 1530 Moss Lat 59.43569487 Lon 10.66681433

# **Report Overview**

This inspection and report cover the entire tree stock under the curtilage of Kongensgate 21, Moss, paying special attention the to the large Fagus tree located at Easting: 594543, Northing: 6589753. The client, Oslo House AS and Architect, Edit-atelier are concerned about the health of the tree stock and the safe retention of high value trees.

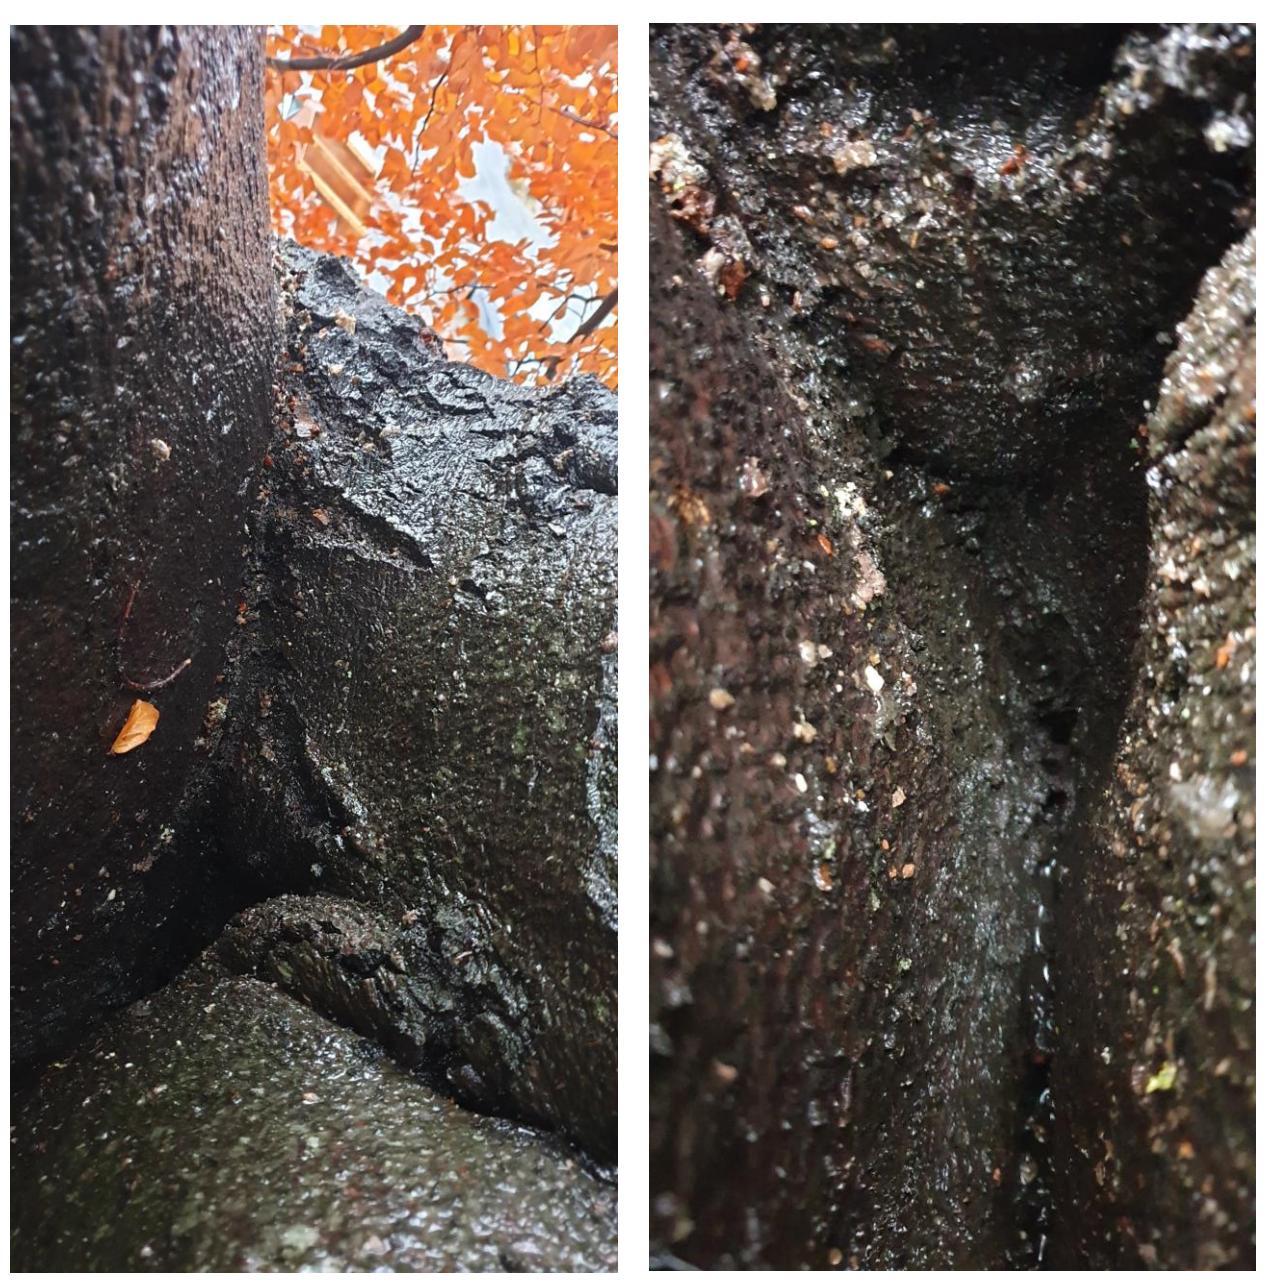
Main union at 2 m fundamentally flawed with					monitoring at all
		included bark on two main unions, however probing					intervals which may
		finds no deep cavities, but solid bark and wood (see					impact health.
		Picture 4&5)					Subsequent health
		Han an analta an North aide of North Doot store					and condition surveys
		Upper cavity on North side of North East stem					are required annually
		ago Cavity chamber is approximately 20 cm in					vears after completion
		diameter cavity entrance is 10 cm across decreasing					of the project with a
		(healing over) and cavity is solid below 20 cm deep.					view to extending the
	Fagus	The wall of the cavity is about 10 to 15 cm thick on the					survey to every three
T1	syľvatica	North side.	G	L	150	2	years after that.

Picture 4&5 – Main union with inclusion of bark/cambium layer causing an inherent weakness, however no deep cavities or excessive decay was noted on inspection

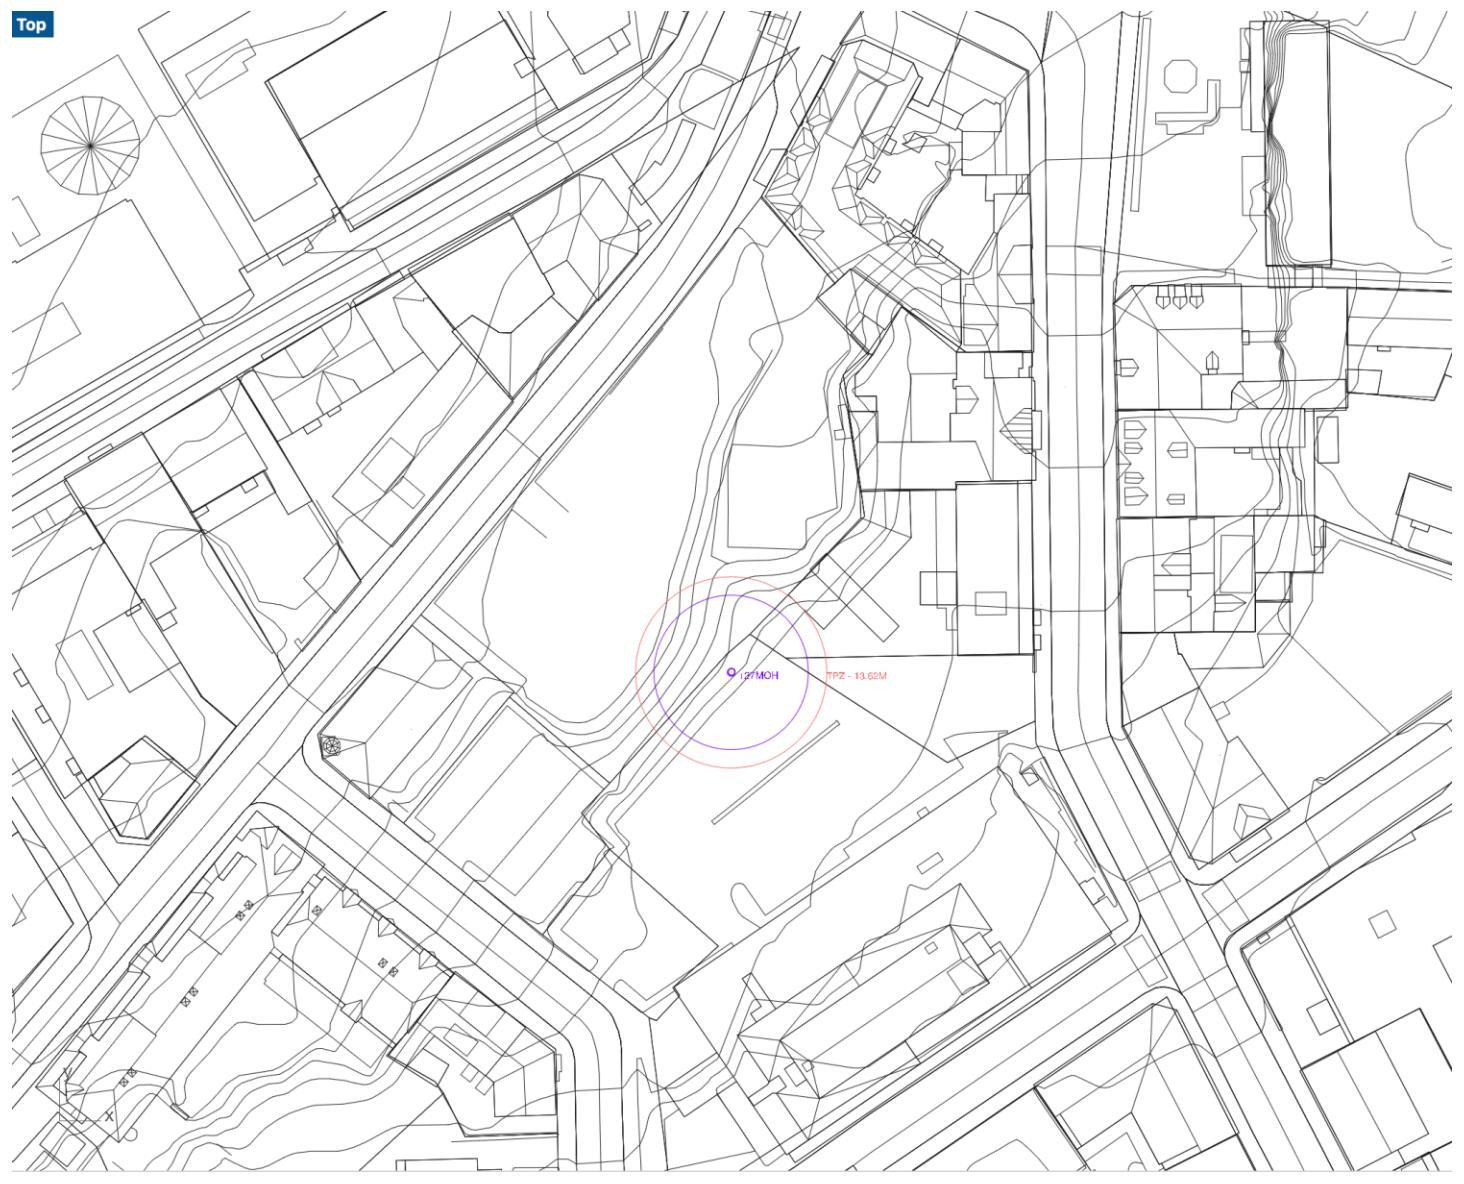
Picture 6 – Positioning of T1 showing crown reach (purple) and root protection zone(red). Any work inside the root protection zone should be accompanied by an arborist.

- Tree protection zone- this is a physical barrier set up to prevent construction related activity in the trees immediate proximity, in this case for T1 we recommend a circular work zone with a radius of 13.62m. This should be made of solid builders fencing and labelled with 'No Entry' signs.
